# Minimally Invasive Porcelain Repair Using High-Strength, Wrapped Aesthetic Veneers

Larry Herwig,  
DDS

This article describes 2 cases that present minimally invasive repair methods for salvaging damaged porcelain in the mouth.

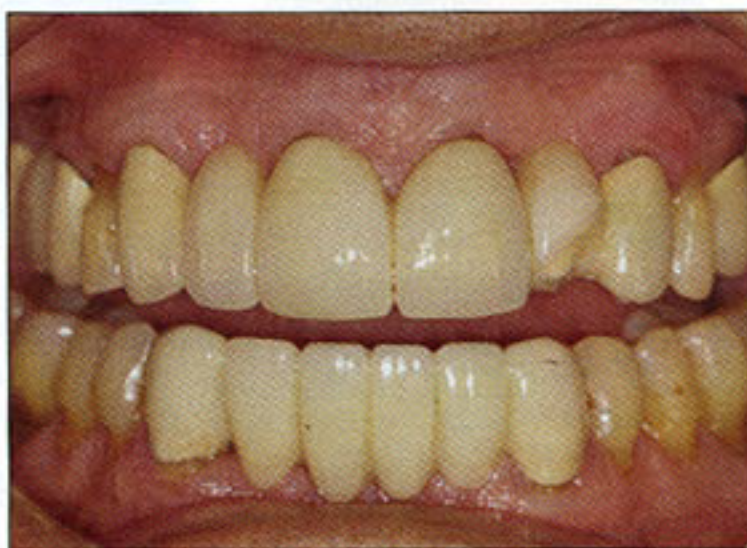
A 68-year-old male with a 2-year-old 6-by-11 bridge presented with fractured porcelain on the facial-incisal aspect of No. 10 (Figure 1). This was the result of a direct blow to the face from a metal gate kicked by an uncooperative young bull trying to escape loading into a pen about a month earlier. Fortunately, the fracture was confined within the facial embrasures of the pontic No. 10, and no other areas were damaged except for facial bruising and cuts. Upon radiographic examination, no root fractures were found, and margins of the bridge were intact. The patient was asymptomatic to percussion, temperature, and air, and he was only concerned about the appearance

Figure 1. Fractured porcelain bridge pontic No. 10.

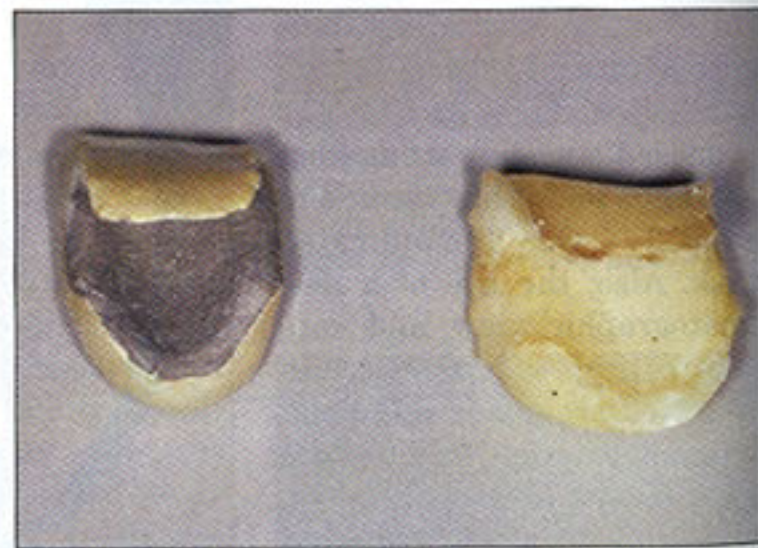
Figure 2. Gingival view of PFM and temporary overlay.

clearance and draw for a PFM overlay. The transition from facial to lingual over the metal bridge framework at the mesial and distal margins gives the provisional and permanent overlays the appearance of a taco shell shape when viewed from the gingival aspect (Figure 2). After final impressions with Examix NDS heavy body/injection (GC America), a cold-cured acrylic provisional was cemented with Neo-Temp (Waterpik Technologies). The final restoration was fabricated by Carter Dental Lab using a solid working model and no individual dies. A cast, high noble metal

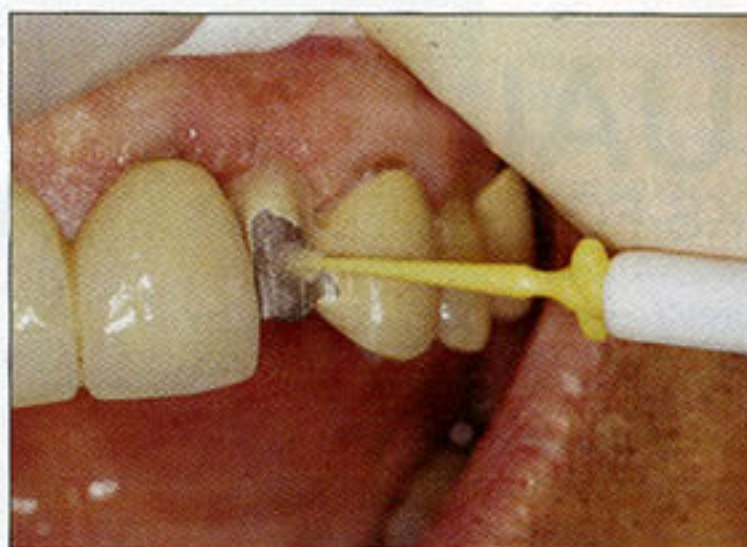
Figure 3. Metal primer application to bridge final prep.

(Euro [Argen]) coping was veneered with Ceramco3 porcelain (DENTSPLY Ceramco). The PFM taco shell crown was seated over the remaining bridge framework and luted into place using LINKMAX (GC America) metal primer (Figure 3) and resin cement (Figure 4). The restoration has now been in place for 2 years without incident.

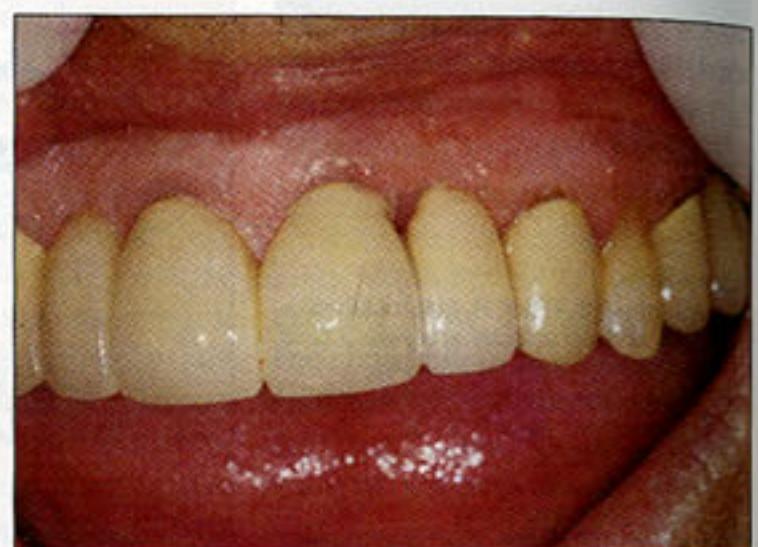
Figure 4. Final resin cementation of PFM overlay.

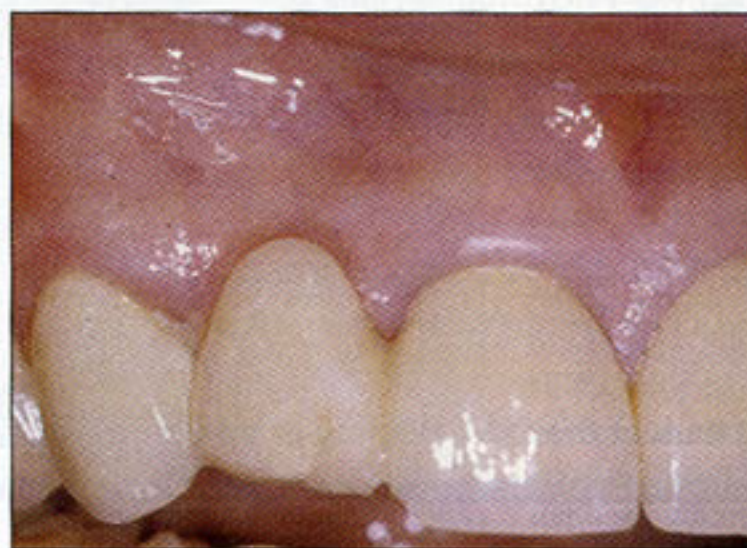
Figure 5. Fractured porcelain bridge pontic No. 7.

A 66-year-old female presented with fractured mesial-incisal-facial porcelain on tooth No. 7 of a 6-by-8 bridge after eating a "soft" breakfast one morning (Figure 5). All radiographic and diagnostic tests for root fractures or pulpitis were negative. Within the last

fractured teeth, fillings, and crowns, and had been told of bruxing. Her muscles of mastication were extremely developed, and her most recent dental work displayed signs of wear. It was evident she was a bruxer, and her recent personal events of relocation and family medical issues had likely contributed to increased bruxing activity and ultimately this breakage.

The options of completely remaking the 6-month-old 6-by-8 bridge, attempted repair with bonding materials, or porcelain overlay were discussed. A final decision of a porcelain overlay was agreed upon.

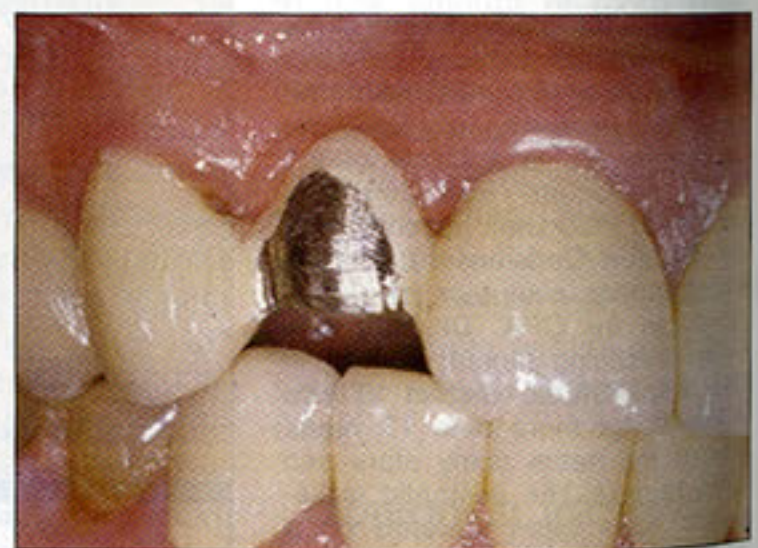
Figure 6. Final preparation of bridge pontic for porcelain overlay.

The bridge was prepped similar to the previous case (Figure 6), and an acrylic temporary was fabricated and cemented after final impressions with Examix. After consulting with the laboratory (Carter Dental Lab), a Cercon coping with Ceram S porcelain veneered surface (DENTSPLY Ceramco) was fabricated (Figures 7a and 7b). Both the bridge and the porcelain were conditioned and cemented with GC Fuji PLUS cement kit (GC America; Figures 8a and 8b). Immediately, impressions and bite records were taken to fabricate a custom acrylic bruxing splint. This was delivered the same week, and the patient was instructed to wear it every night. The patient has had no further breakage of either porcelain or natural teeth since then.

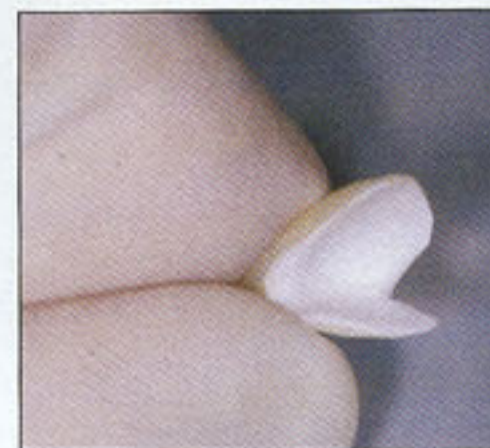
Figure 7a. Final Cercon overlay: gingival view.

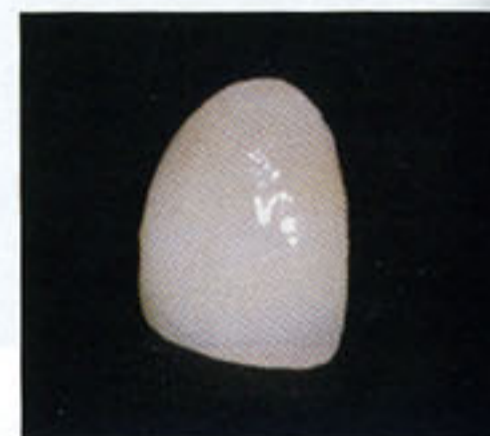
Figure 7b. Final Cercon overlay: facial view.

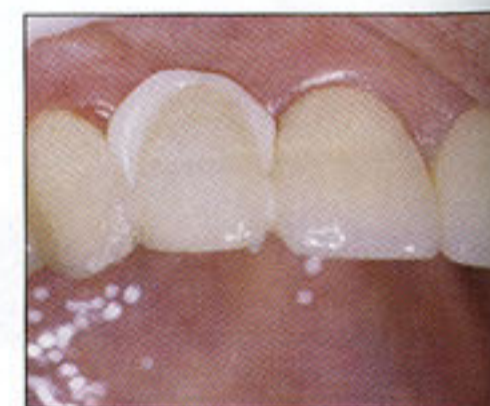
Figure 8a. Cercon overlay cementation with GC Fuji PLUS.

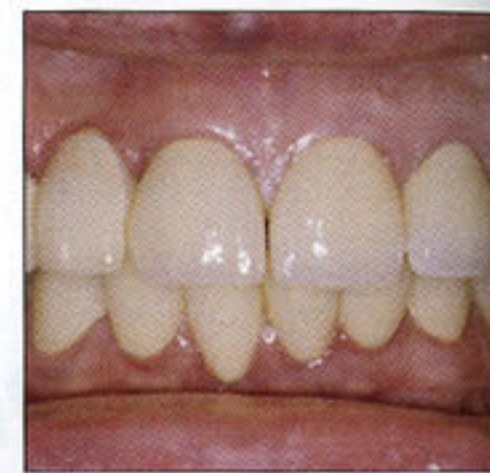
Figure 8b. Final Cercon overlay repair of porcelain bridge pontic No. 7.
